Tracking Generator and Reflection Bridge/VSWR Troubleshooting

Here are some common options for trouble with tracking generator/Reflection bridge/VSWR measurements

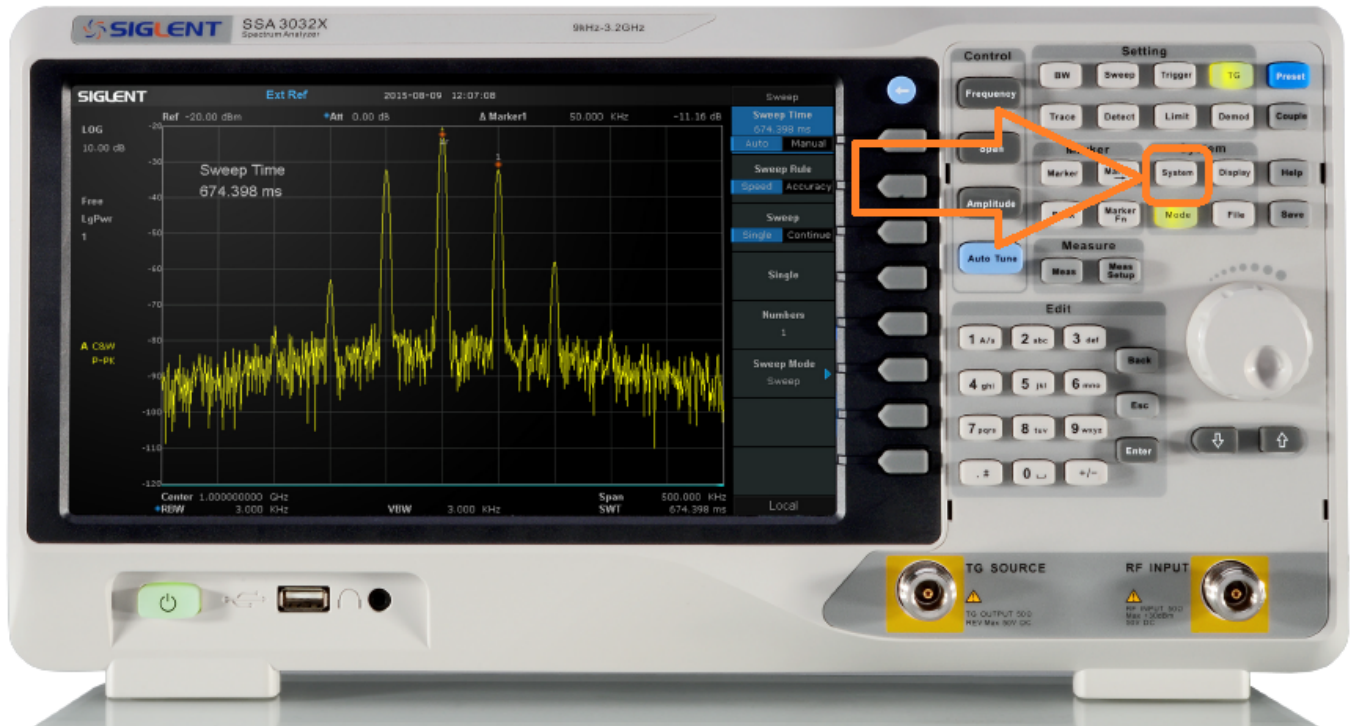
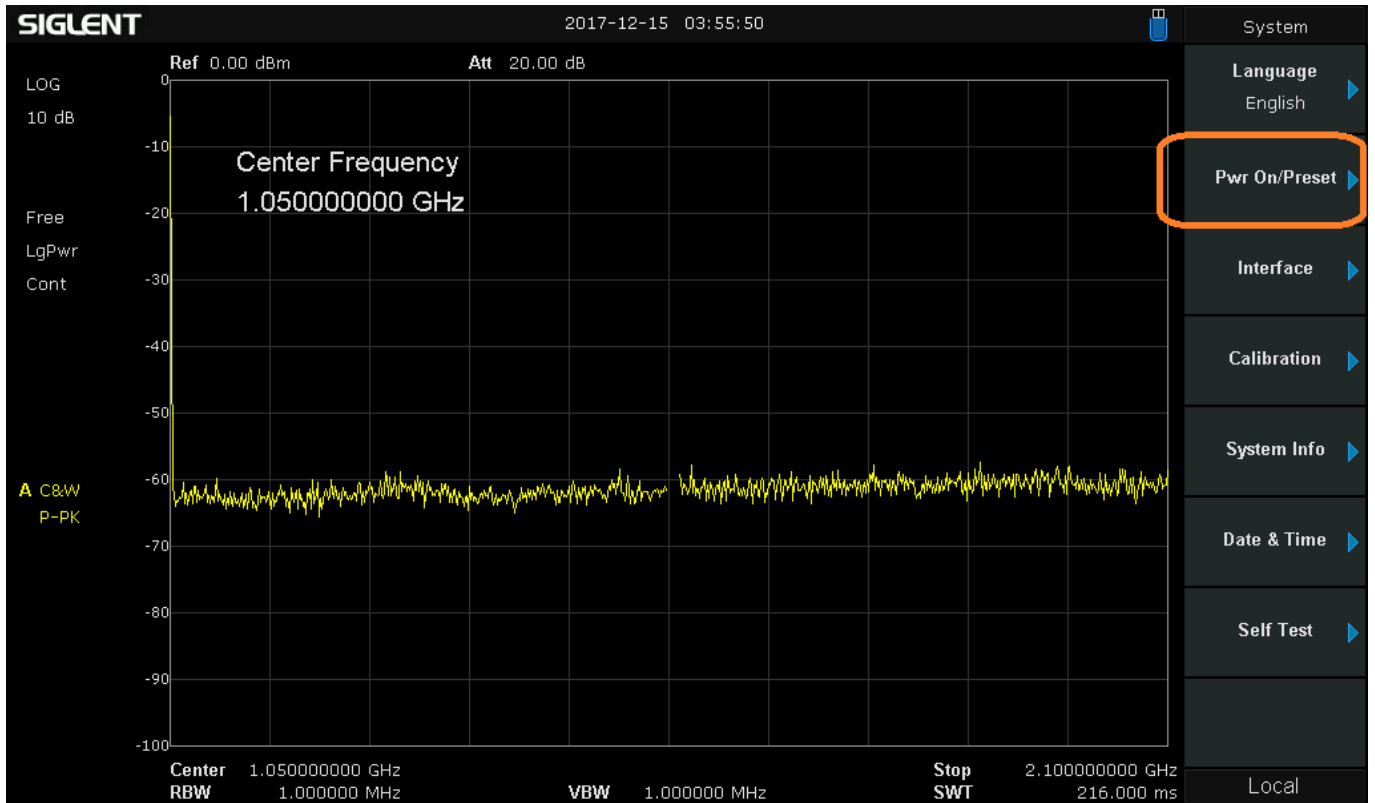
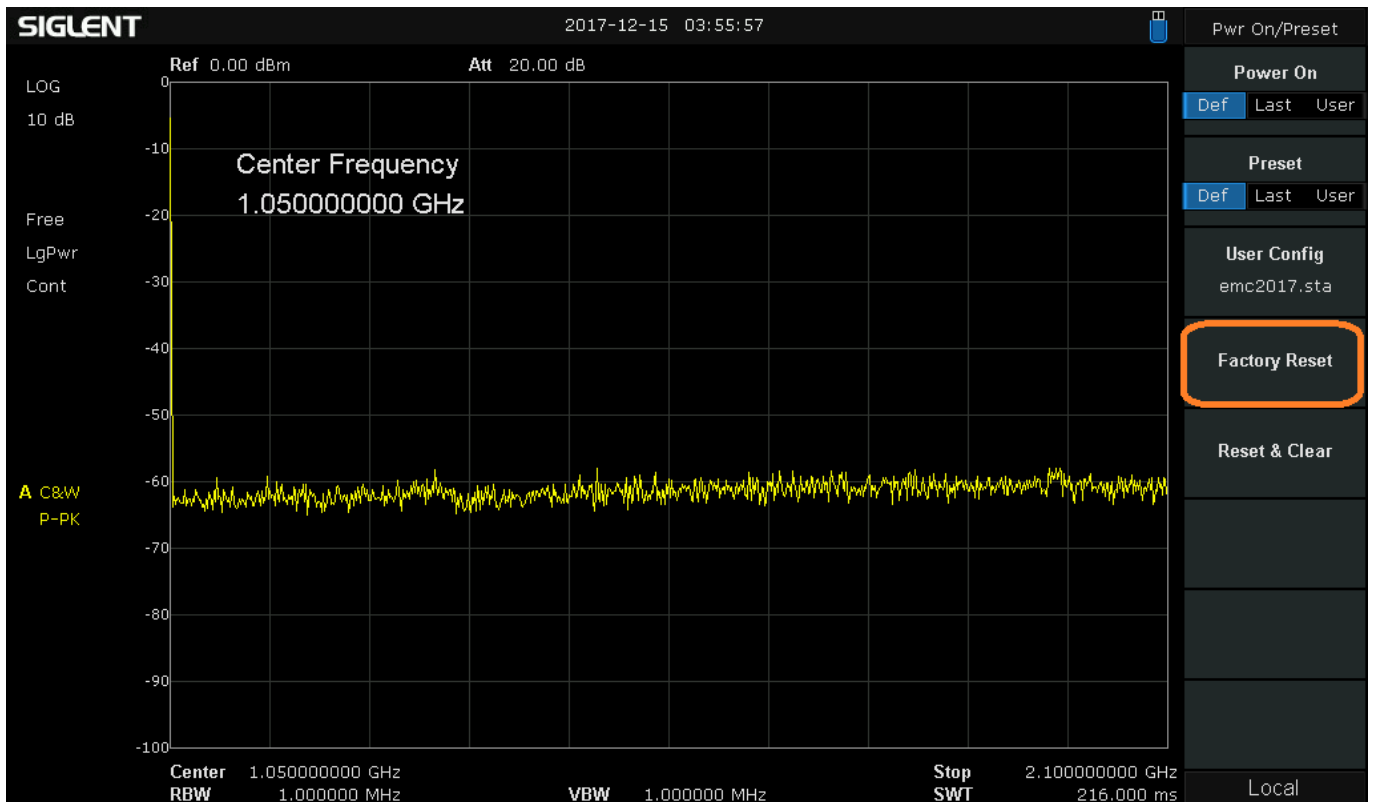
1. Set the instrument to factory defaults by pressing SYSTEM > PWR ON/Preset > Factory Reset

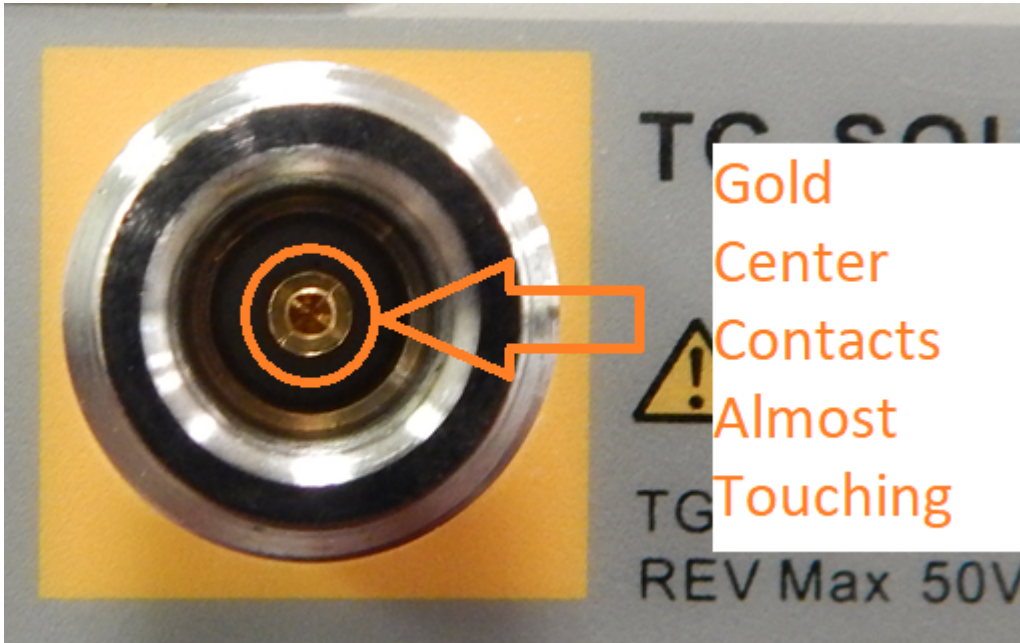
- Are the center conductor contacts very close to one another? No gaps and no broken/missing petals on the inner gold contacts?

Here is a good TG output connector:

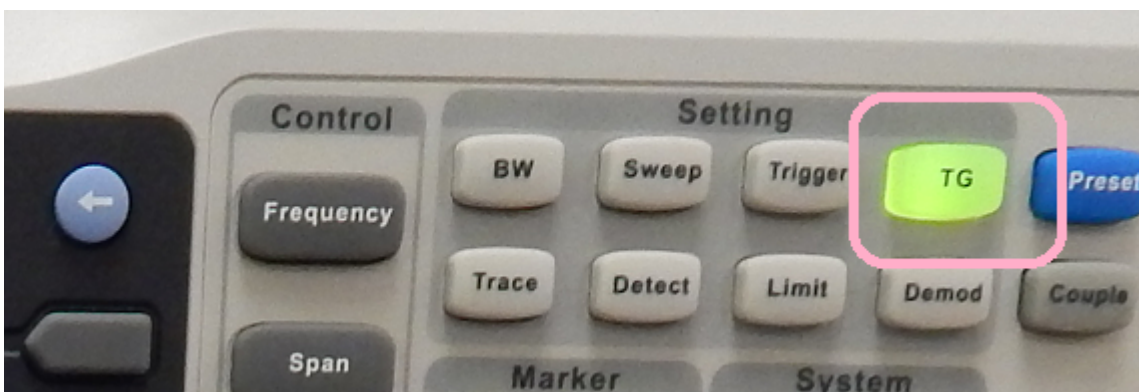
4. Is the TG output enabled? This is indicated by an illuminated TG button on the front panel:

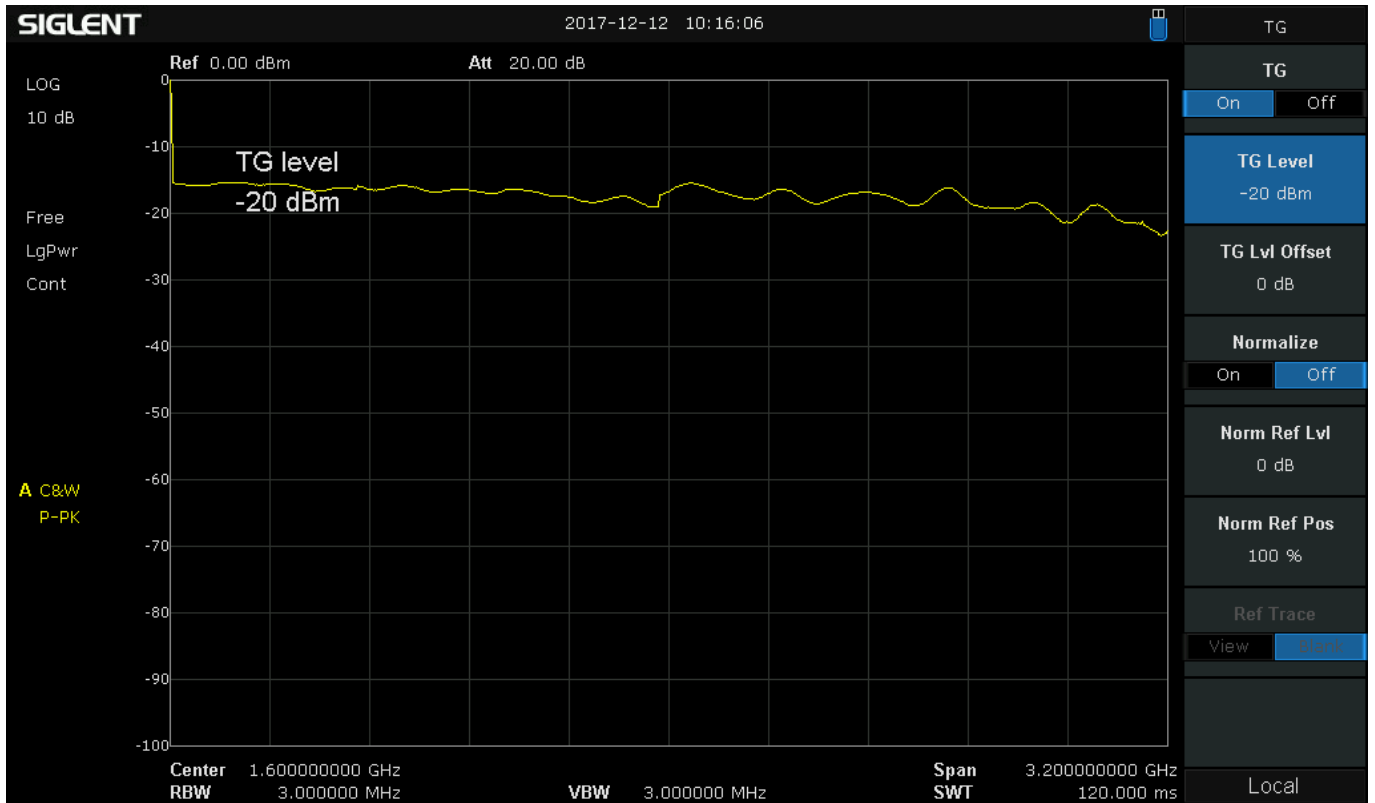
The average output should be equivalent to the setpoint and the flatness should be within 3dB of that setpoint. If not, there is likely an issue with the TG, RF input, Cable, or connectors.

Here, the TG is ON, and is set to -20 dBm (TG Level)..

NOTE: There may be additional losses due to cable type, age, connectors, and any adapters that are in the signal chain.

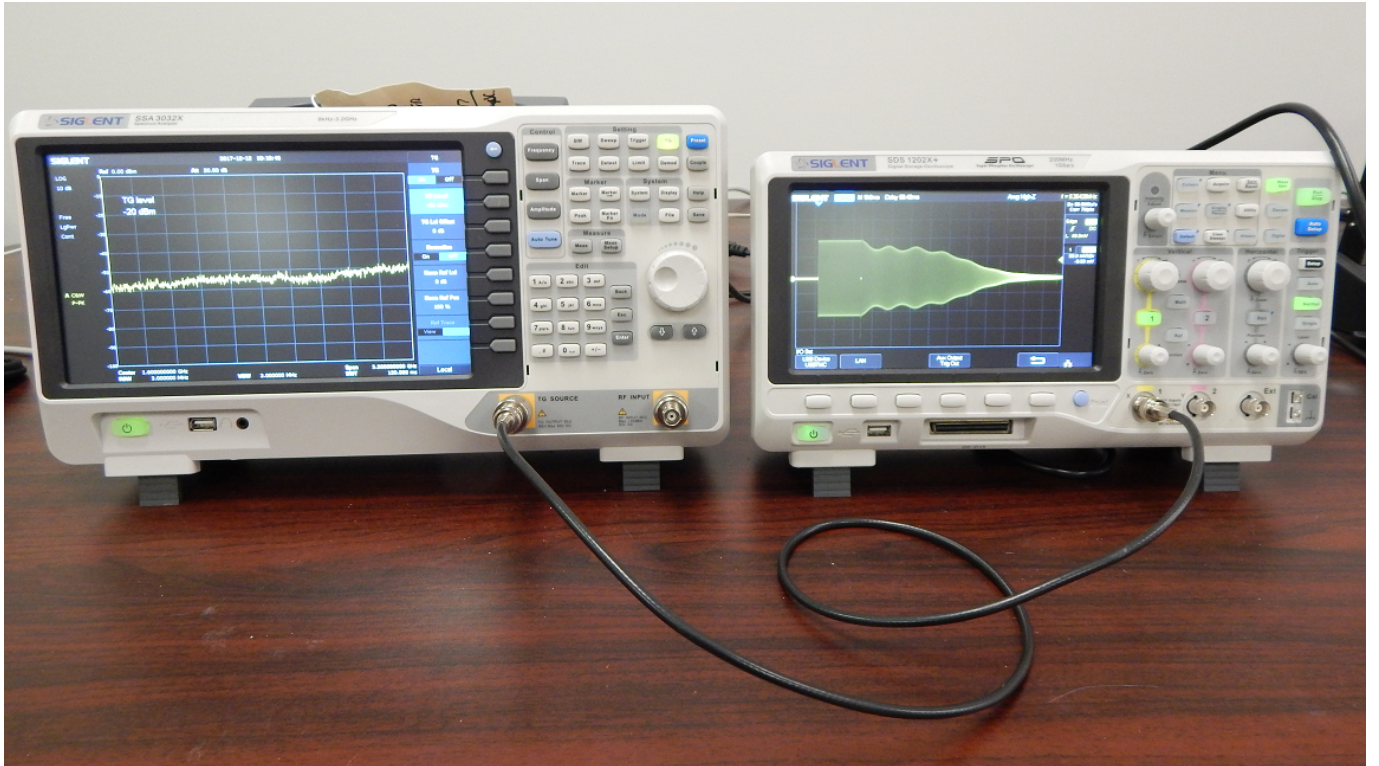
6. You can also check the TG output with an oscilloscope
