Tracking Generator and Reflection Bridge/VSWR Troubleshooting

Here are some common options for trouble with tracking generator/Reflection bridge/VSWR measurements

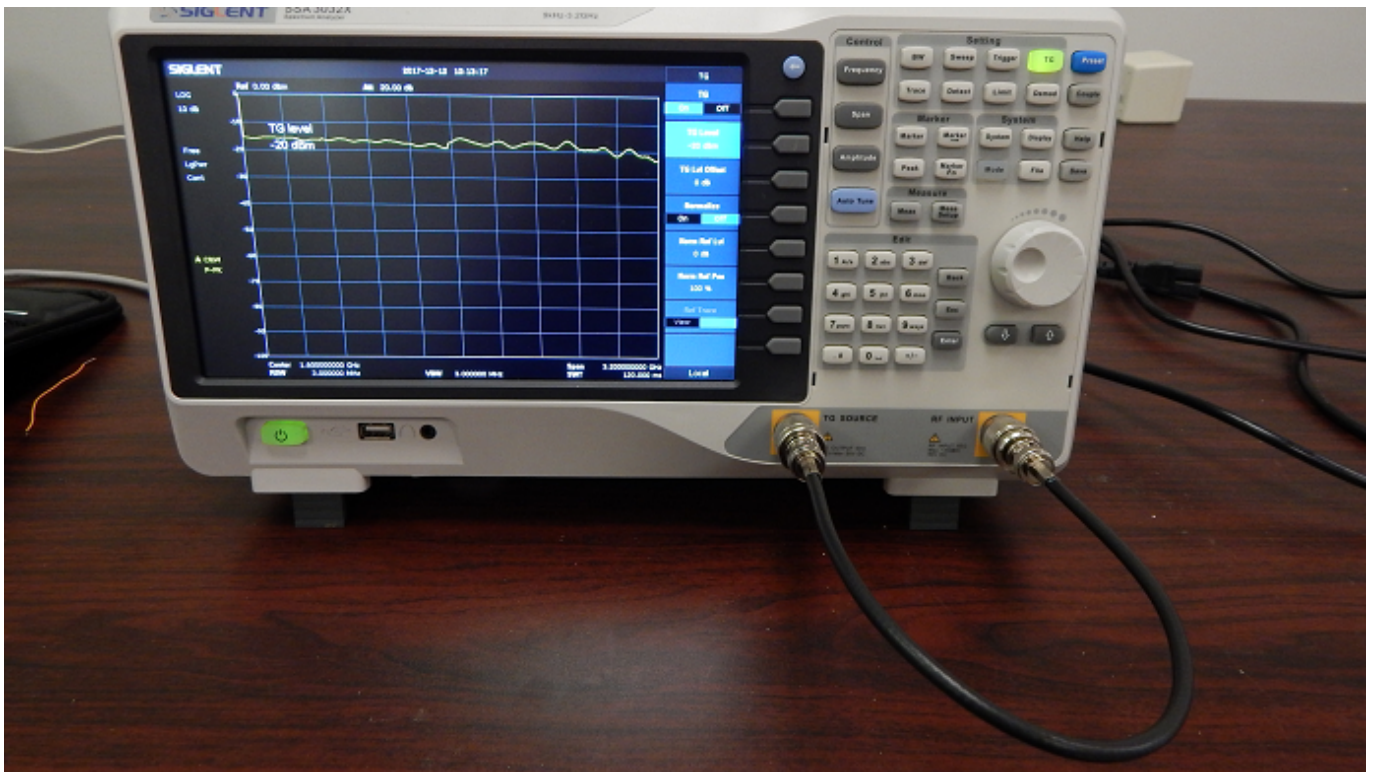
Connect a cable from the TG output to the RF input and enable the TG:
